Wood Products Victoria Ltd

Guide to Assessment and Repair of Flood Damaged Timber and Timber Framed Houses

(15 February 2011)

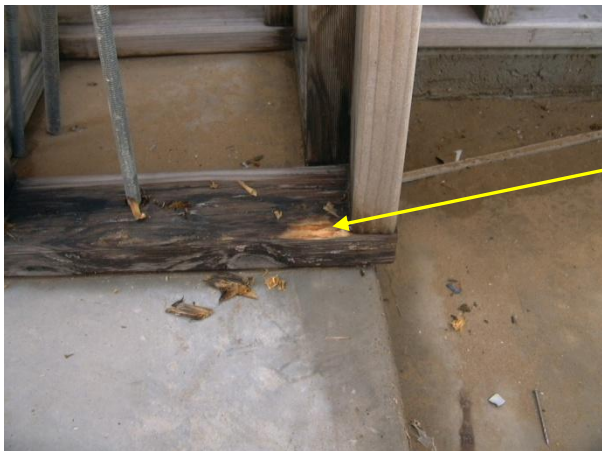
Although heavily discoloured with surface mould and blue stain, the pine timber is still sound as shown by scraping back the surface layer

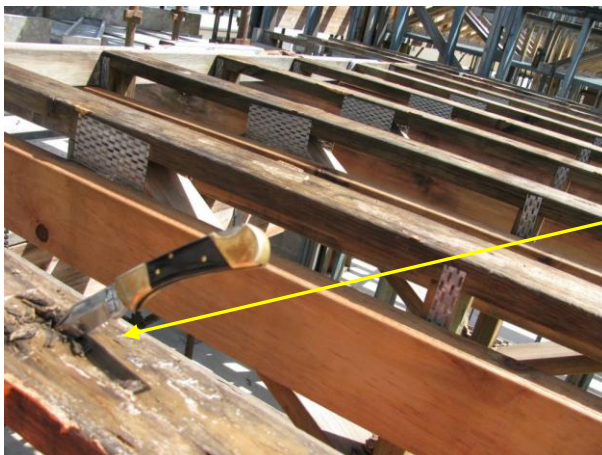
Decayed timber is soft and spongy and can easily be penetrated with a knife or screwdriver

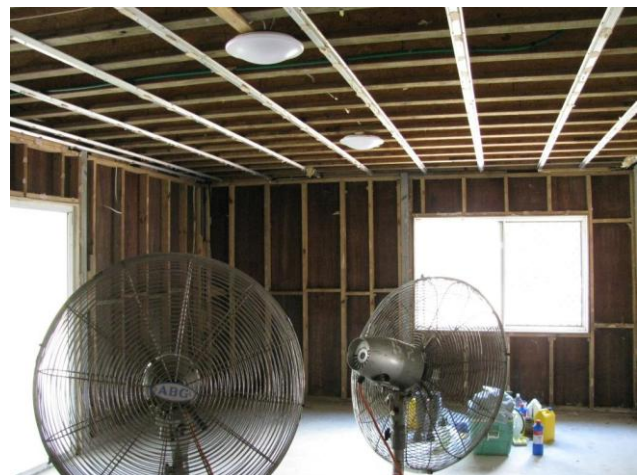
Lining should be removed to at least 300mm above the highest level of inundation (or further if required for adequate re-instatement of the lining i.e. half wall height or full wall height). Inundated bulk (batts) wall or ceiling insulation will need to be removed and replaced during cleaning and repairs.

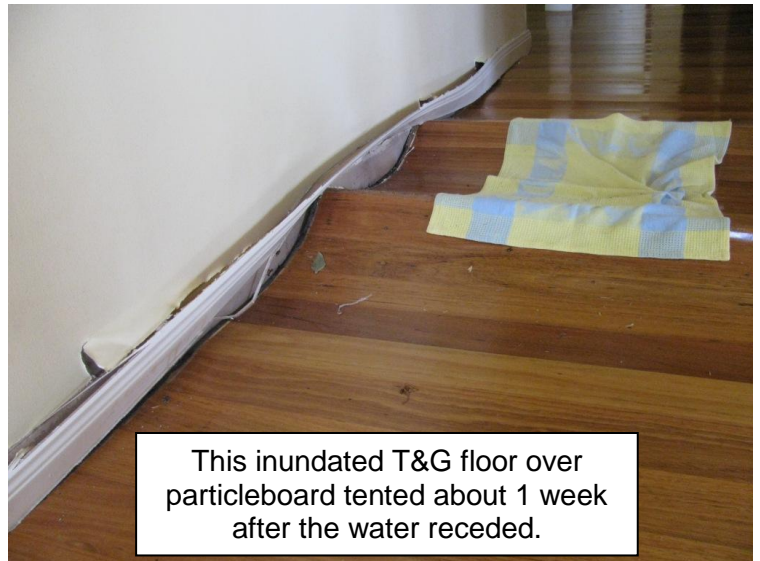
The flooring may continue to swell or expand across the boards for a period of time even after the water has subsided as moisture moves deeper into the timber. After cleaning, assess the extent of swelling and or tenting of boards (lifting off the supports). Check to see if there is still clearance between the edges of boards and the bottom plates of walls (usually under the skirting board) and to see if the flooring has expanded and started to push wall frames out at the bottom. If necessary relieve the pressure on walls by removing or cutting out perimeter boards. Eliminate any trip hazards that may have arisen due to tenting of boards or lifting of nails etc.

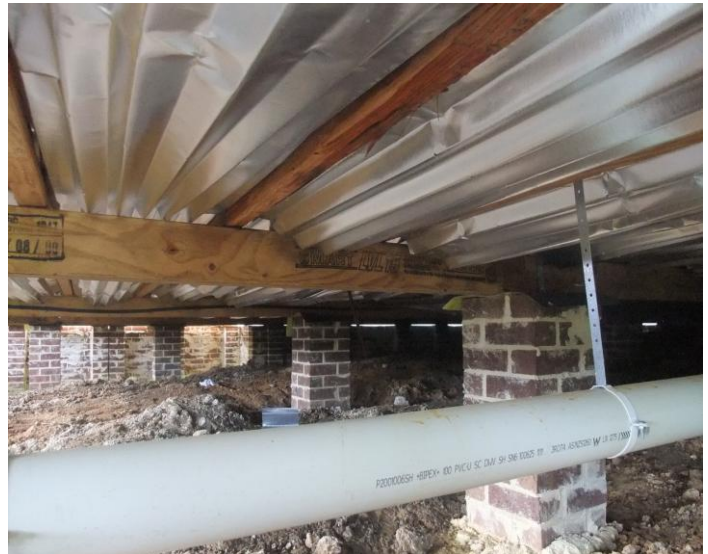
A wide range of construction options exist to suit any site soil conditions or any house cladding option.

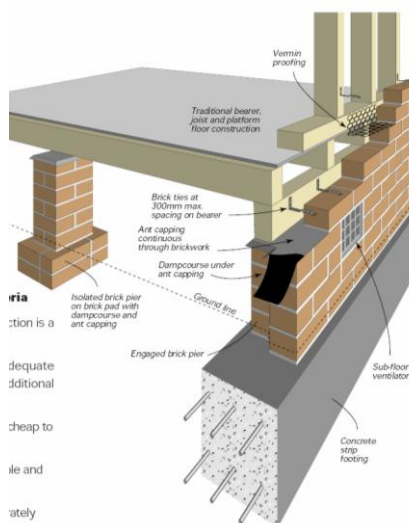
Traditional raised timber sub-floor on brick sub-wall

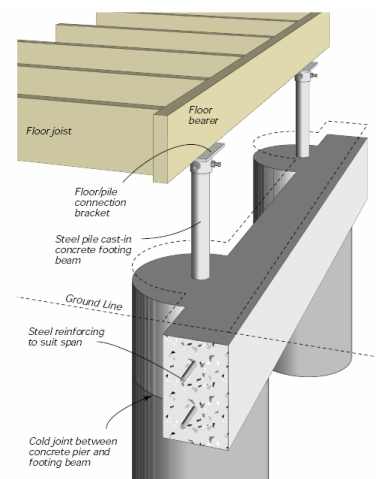
Raised timber sub-floor on cast-in steel posts
